DPR Avoids Substantial Construction Delays by Finding Out-of-Tolerance Interior Steel Beams with Verity

Verity Identified As-Built Deviations in More Than 50% of Horizontal and Vertical I-Beams

The Project: High-End Retail Site in Downtown Nashville

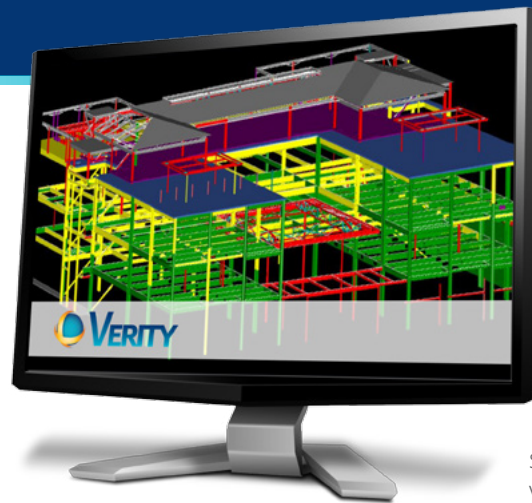
More than 50 percent of the installed steel was out of tolerance, with numerous beams deviating substantially from the design intent. Verity generated a detailed HTML report as well as a color-coded model

of the entire structure, which confirmed a deviation cascade from the ground up. There were 19 and 39 members out of tolerance on the first and second floors, respectively. Nearly all were out of tolerance on the third floor. The Verity report allowed DPR to evaluate each steel beam individually to determine if the deviation required a field inspection. One critical beam was designed to angle down but was installed flat, a scenario that would likely have been missed by spot checks.

Forty-five elements were flagged because they were either missing or were so far out of tolerance they could potentially impact construction of the exterior building skin—one exterior beam was out of tolerance by more than two inches, seriously jeopardizing the fit of the yet to be installed cladding.

DPR sent crews to the site with 2D schematics to review the 45 flagged deviations. This information was also supplied to the designers to determine how to best remediate the problems prior to beginning the installation of exterior building skin. In addition, DPR ran the as-built model back through Navisworks to perform clash detection so field crews would be ready for future problems before they arise. Potentially major delays were avoided using Verity.
