Verity Helps Beck Keep the Water Flowing at Hospital by Finding Pipe Installs Improperly Documented

Verity Updates As-Built Documents for Plant Room

The Project: Central Utility Plant at a Texas Hospital

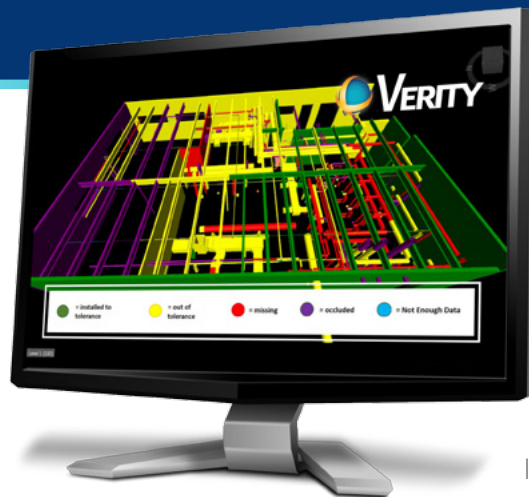
In addition to a written tabular report showing element deviations, Verity generated a color-coded schematic of the site in Navisworks. Beck queried each feature in the report and found that most steel, HVAC and sprinkler members were within the designed location tolerance.

Verity's "stop light" variance classification gave Beck a quick overview of construction quality.

Verity found that many of the water pipes smaller than six inches were not installed within the location parameters of the coordinated model. Beck's VDC teams investigated and discovered the pipes were often installed several feet from their locations in the design plans and as-built drawings. This was not a mistake; the pipe installers had found a more efficient way to
