Spotland Pinpoints Problems in Roof Installation by Finding Out-of-Tolerance Steel Beams with Verity

The Project: Multi-Building Health Care Facility in Ballerup, Denmark

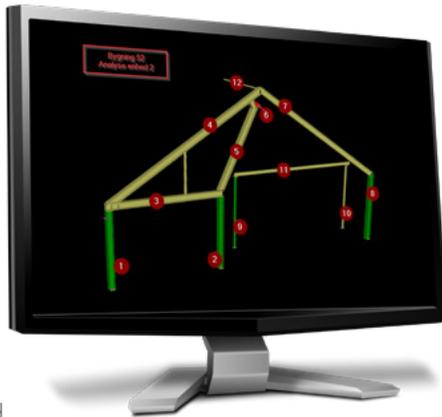
The Spotland crew used a FARO laser scanner to collect scans from inside, outside and above each of the four remaining building structures. The scans were processed into a separate point cloud for each building and imported into Autodesk Navisworks where Verity had been integrated into the workflow via plugin. Spotland obtained a CAD model of the steel structure design for comparison with the as-built point clouds. A 10-mm tolerance was selected in Verity, which then analyzed

each individual beam to see if it deviated more than that distance from its designed position along the x, y or z axis. The software even checked for unplanned twists, bends and sags in the members.

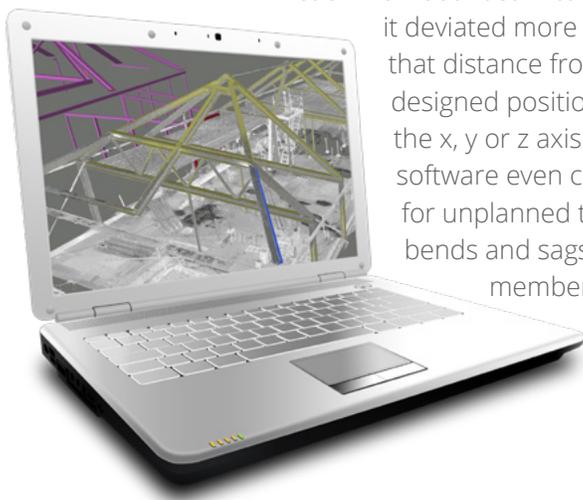
each individual beam to see if it deviated more than that distance from its designed position along the x, y or z axis. The software even checked for unplanned twists, bends and sags in the members.

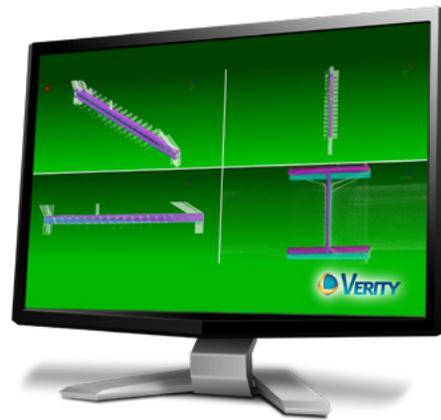
Verity generated a tabular report showing its analysis of each beam, which could be queried to see detailed measurements of how far each OOT element deviated from its design location along each axis. Spotland provided this information to

the General Contractor for evaluation of which deviations were acceptable and which weren't. About eight beams in the roofing trusses of the first building scanned were found to have bends and

twists that probably were preventing the prefab roof segments from being installed properly.

Similar bends and sags were found in roof beams with Verity in the second of the four unfinished buildings, prompting the General Contractor to call a meeting with the steel installer to decide how best to fix the problems before bringing the roof installers back onsite. The General Contractor knew it was less expensive to delay construction before the expensive roofing crew arrived. Potentially major cost overruns were avoided using Verity.
