### DPR Avoids Substantial Construction Delays by Finding Out-of-Tolerance Interior Steel Beams with Verity

#### Verity Identified As-Built Deviations in More Than 50% of Horizontal and Vertical I-Beams

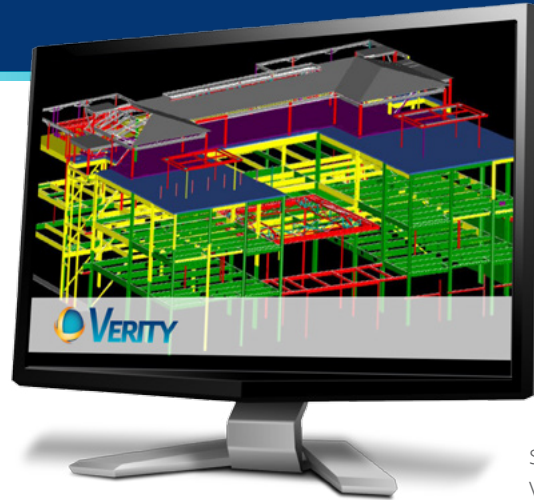
Using a Trimble TX8 3D laser scanner, DPR captured 73 scans of the interior and exterior of the three-story building skeleton in five hours. After registering in Trimble RealWorks, the point cloud and design model were imported into Autodesk Navisworks which has deep data integration with Verity. From there, the model and point cloud were brought into Verity and analyzed by the software for deviations. DPR set Verity to inspect each of the 583 steel beams (mostly 20-foot-long I-beams) to a one-inch tolerance in x, y and z coordinate planes. Verity ran overnight and completed the analysis in eight hours, generating a detailed report showing variances for each steel member.

More than 50 percent of the installed steel was out of tolerance, with numerous beams deviating substantially from the design intent. Verity generated a detailed HTML report as well as a color-coded model

of the entire structure, which confirmed a deviation cascade from the ground up. There were 19 and 39 members out of tolerance on the first and second floors, respectively. Nearly all were out of tolerance on the third floor. The Verity report allowed DPR to evaluate each steel beam individually to determine if the deviation required a field inspection. One critical beam was designed to angle down but was installed flat, a scenario that would likely have been missed by spot checks.

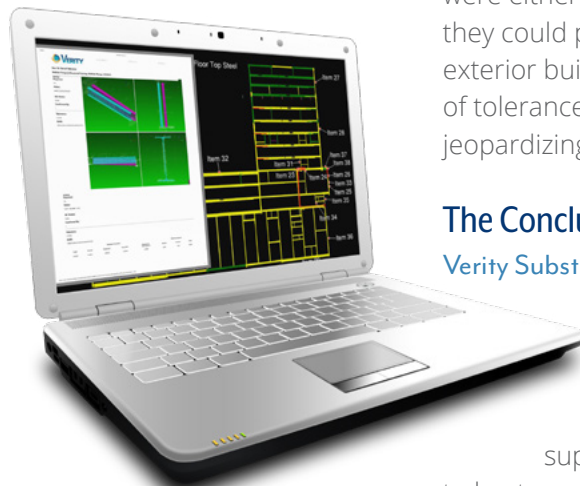
DPR sent crews to the site with 2D schematics to review the 45 flagged deviations. This information was also supplied to the designers to determine how to best remediate the problems prior to beginning the installation of exterior building skin. In addition, DPR ran the as-built model back through Navisworks to perform clash detection so field crews would be ready for future problems before they arise. Potentially major delays were avoided using Verity.
